Issue Evaluation

Issue:	IE07-080
Date Submitted:	5-Sep-07
Subject:	Non-Deployment of Airbags
Prompted by:	Consumer Complaints/Fatal Crash Reports
Supported by:	Consumer Complaints / EWR Data
Investigator:	Donovan Green / Daniel Hillman
Subject Vehicles:	2003, 2004, 2005 Saturn Ion 2005, 2006 Chevy Cobalt
Population:	Saturn Ion: 288,463 Chevy Cobalt: 389,203
Problem Description:	Driver and passenger side frontal airbags fail to deploy during crash events where injury severity, CDR data, structural deformation and deaths suggest the airbags should have deployed.
Complaints	29
Crashes	29
Injuries	11
Deaths	4
Other (Describe "Other")	14 (Field Reports)
Additional Comments

ISSUE EVALUATION MEMORANDUM

The frontal airbags in the 2003/2004 Saturn Ion and 2005/2006 Chevy Cobalt may not deploy in certain crash events where supporting evidence shows that the airbags should have deployed. Failure of an airbag to deploy can result in reduced protection for vehicle occupants, and may result in injury or death.

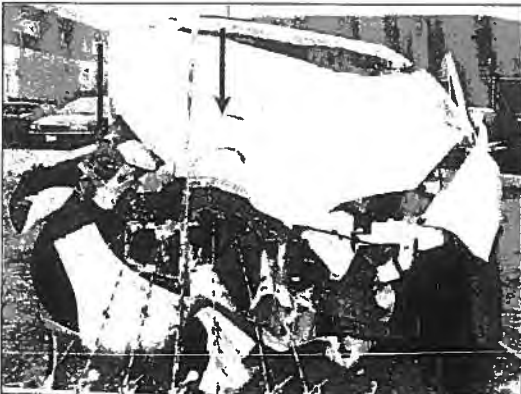
Figure 4: Damage to case vehicle from impact with clump of trees, red arrow shows impact location of tree that broke off, green arrow shows impact location of second tree. vertical scale in tenths of meter

Exterior Damage: The case vehicle's initial impact with the telephone utility box involved the center portion of the front bumper. The precise location of the damage could not be determined due to the overlapping damage and missing portions of the front bumper fascia. The case vehicle's impact with the tree involved the front right portion of the case vehicle. The front bumper, grille, hood, and right fender were directly contacted and crushed rearward. The direct damage began at the front right bumper corner and extended approximately 45 centimeters (17.7

inches) along the front of the of the vehicle. The front crush profile was taken at the bumper level. The maximum residual crush was determined to be 121 centimeters (47.6 inches) occurring at C₃ (Figures 7 and 8). The direct damage from the tree branch impact involved the roof and the backlite. There was a dent located near the right “C”-pillar and the backlite was broken out.

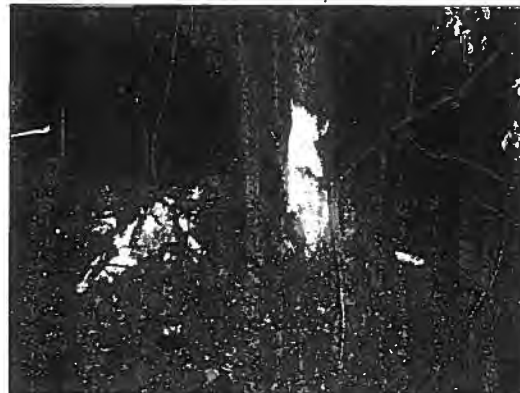
Figure 5: Police on-scene photo of impacted clump of trees, arrows shows broken/uprooted tree

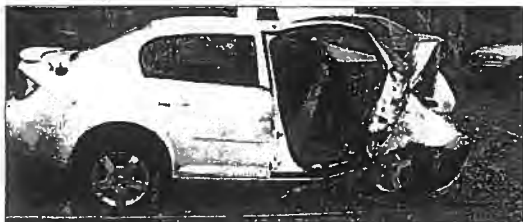
Figure 7: Right side view of crush to front of case vehicle from impact with clump of trees

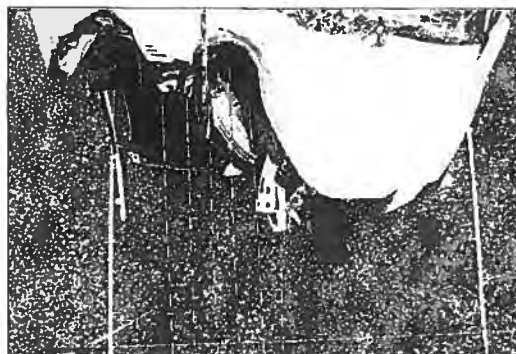
Figure 8: Top view of crush to front of case vehicle from impact with clump of trees, each increment on rods is 5 cm (2 in)

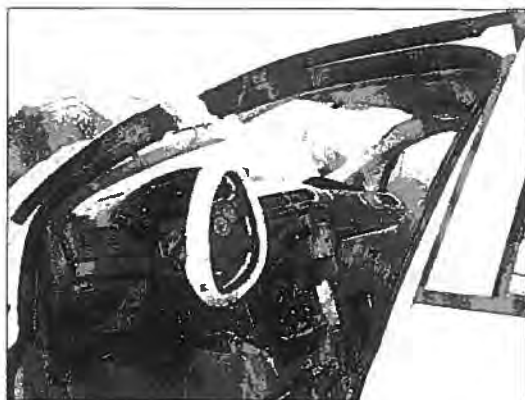
Vehicle Interior: Inspection of the case vehicle's interior (Figures 9-11 below) revealed that the right side of the steering wheel was severely bend forward and the steering column crushed forward and upward (Figure 12 below) due to driver loading. The driver's knee bolsters had been heavily contacted by the driver's knees and broken out. There were scuff marks on the right instrument panel and glove box door due to loading by the front right passenger. The front right passenger's seat back was also deformed forward due to loading by the unrestrained back right passenger. Passenger compartment intrusion involved the driver's and front right passenger's toe pans, which intruded longitudinally 18 centimeters (7.1 inches) and 23 centimeters (9 inches) respectively. The brake pedal also intruded longitudinally 18 centimeters (7.1 inches), and the right instrument panel intruded 18 centimeters (7.1 inches) into the front right passenger's occupant space. Lastly, the front right passenger's seat back intruded forward nearly to the instrument panel (Figure 10 below).

Figure 9: Overview of steering wheel, instrument panel and windshield from driver's door

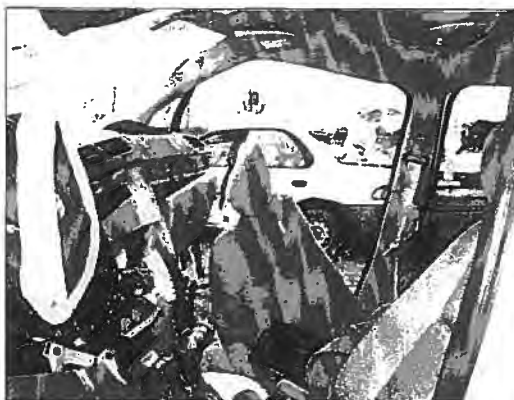
Figure 10: Left side view of steering wheel, instrument panel and displacement of front right seat back due to loading by back right passenger

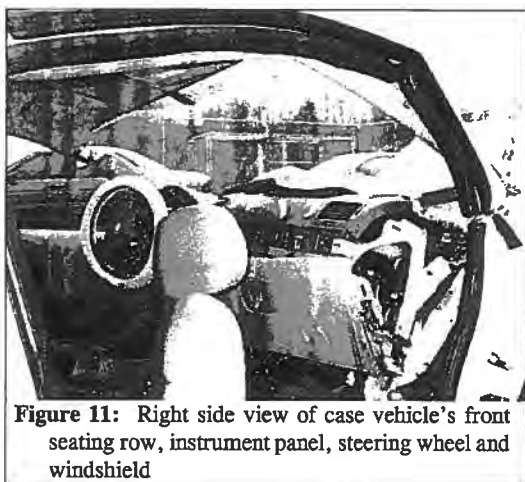
Figure 11: Right side view of case vehicle's front seating row, instrument panel, steering wheel and windshield

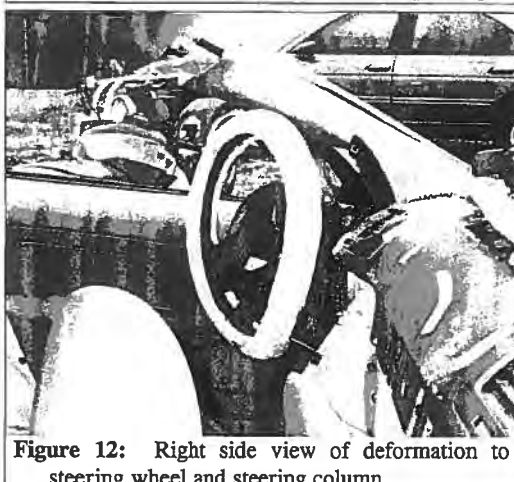
Figure 12: Right side view of deformation to steering wheel and steering column

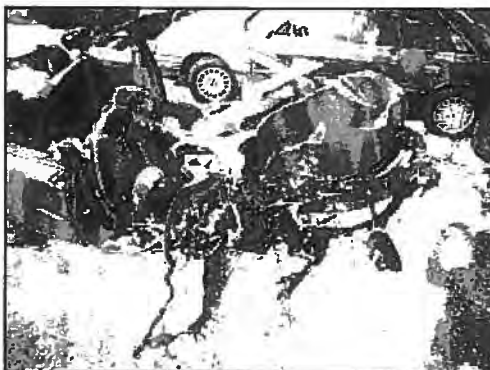
Figure 1. Subject vehicle 2005 Chevrolet Cobalt.

The frontal air bag system did not deploy in the crash. The driver initiated a forward trajectory and loaded the steering assembly. Her loading of the alloy steering wheel rim fractured the wheel flange, thus separating the wheel from the column. The vehicle rotated in a clockwise direction and impacted several small diameter trees with the left side area, which resulted in a lateral rollover onto its right side. The driver came to rest slumped against the right door and remained conscious at the scene. Rescue personnel arrived on-scene and administered emergency treatment. As the driver was moved from her final rest position, she lapsed into an unconscious state and was without a pulse. She was immediately transported by ambulance to a local hospital where she expired within two hours of the crash of severe liver lacerations.

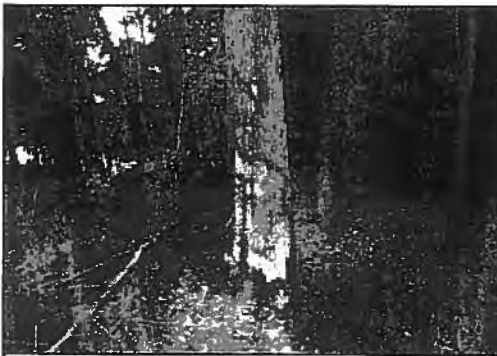
The Cobalt continued forward an additional 2.3 m where it struck a 51 cm (20") diameter hardwood tree with the front right area (**Figure 4**). At impact, the vehicle was in a near tracking attitude, and may have rotated slightly counterclockwise as a result of the initial

As the front bumper beam crushed to a depth of 110 cm (43.4"), the right front tire and wheel engaged the tree. The engagement fractured the alloy wheel and axle, and front suspension components, separating the wheel and brake assembly. The crush extended onto the right side plane of the Cobalt, engaging the right A-pillar and leading edge of the right door. The damage algorithm of the WinSMASH program computed a total velocity change of 61 km/h (37.9 mph) with longitudinal and lateral components of -60 km/h (-37.3 mph) and -11 km/h (-6.8 mph) respectively. The EDR recorded a maximum velocity change of 80 km/h (49.99 mph) at 300 msec of Algorithm Enable (AE). The frontal air bag system did not deploy. Due to the offset right crash, the Cobalt began to rotate in a clockwise (CW) direction as it separated from the tree.

Figure 4. Impact with the 51 cm (20") diameter hardwood tree.

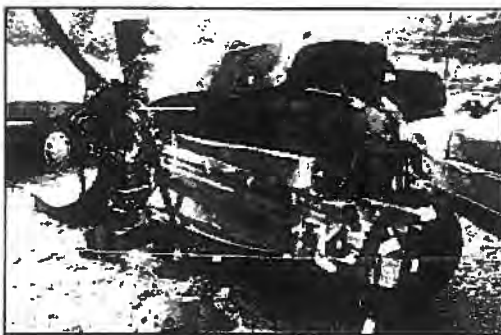
The initial impact with the 13 cm (5") diameter tree was located on the front left area of the vehicle (**Figure 7**). The direct contact damage began 29 cm (11.4") left of center and extended 11 cm (4.25") to the left. The impact dented the hood face to a maximum depth of 10 cm (4.0"). The damage and resulting crush to the bumper system was masked by the subsequent impact with the large diameter tree. The Collision Deformation

Figure 7. Damage from the 13 cm (5") tree.

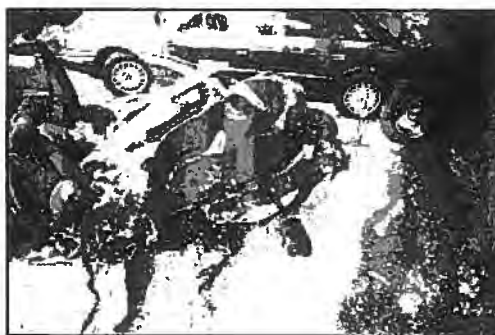
Figure 8. Overhead view of the damage from the 51 cm (20") tree.

The Cobalt uprooted and overrode the small diameter tree as it continued 2.3 m (7.5') forward and impacted the 51 cm (20") hardwood tree with the front right area (**Figure 8**). The direct contact damage began 41 cm (16.25") right of center and extended 33 cm (13") to the front right corner. The damage was concentrated outboard of the right frame rail and initially involved the corner of the bumper beam and sheet metal components. As the vehicle crushed, the right front tire/wheel and axle assembly engaged the tree followed by the right A-pillar area. The right corner impact deformed the full width of the frontal structure. The combined induced and direct contact damage at the bumper level measured 67 cm (26.5"), extending from corner-to-corner of the bumper beam. Maximum crush was measured at 110 cm (43.4"), located at the front right corner of the bumper beam. The crush profile at the level of the bumper beam was as follows: C1 = 12

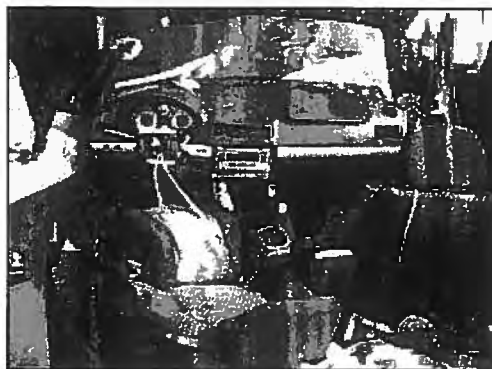
The steering wheel rotated upward as the cowl of the vehicle intruded rearward. The driver's abdominal region loaded the lower aspect of the steering wheel rim. Her loading force fractured the mounting flange of the alloy wheel, thus resulting in complete separation of the steering wheel and air bag module from the column. This assembly was not with the vehicle at the time of the SCI inspection. The separated steering wheel was noted in an on-scene police image of the crash site. In addition to the flange fracture, the driver compressed the energy absorbing steering column as evidenced by 0.6 cm (0.25") of left shear capsule separation and 2 cm (0.75") of right capsule compression. Figure 9 is overall view of the driver's trajectory and contact points.

Figure 9. Driver trajectory and contact points.

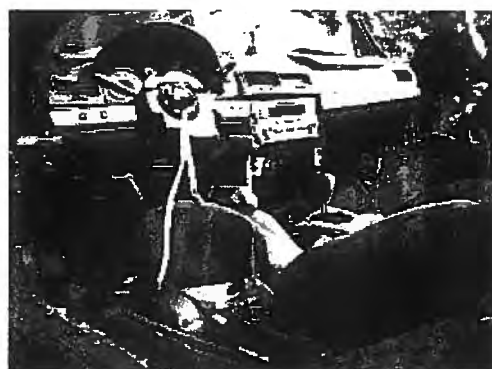
The driver's knees and lower legs impacted the knee bolster (Figure 10). Her left knee scuffed the bolster 15-22 cm (5.75-8.75") inboard of the left edge of the bolster panel and 15-23 cm (5.75-9.25") below the top edge of the plastic panel. The right knee contact was located 44-50 cm (17.25-19.75") inboard of the left edge and 20-24 cm (8-9.5") below the top edge. A fabric scuff from her right leg was noted to the left

Figure 10. Driver contact to the knee bolster.
